Oyster Bed Mapping in the Great Bay Estuary, 2012-2013

A Final Report to
The Piscataqua Region Estuaries Partnership and
New Hampshire Department of Environmental Services

Submitted by
Raymond Grizzle and Krystin Ward
University of New Hampshire
Jackson Estuarine Laboratory, 85 Adams Point Road
Durham, NH 03824

June 26, 2013

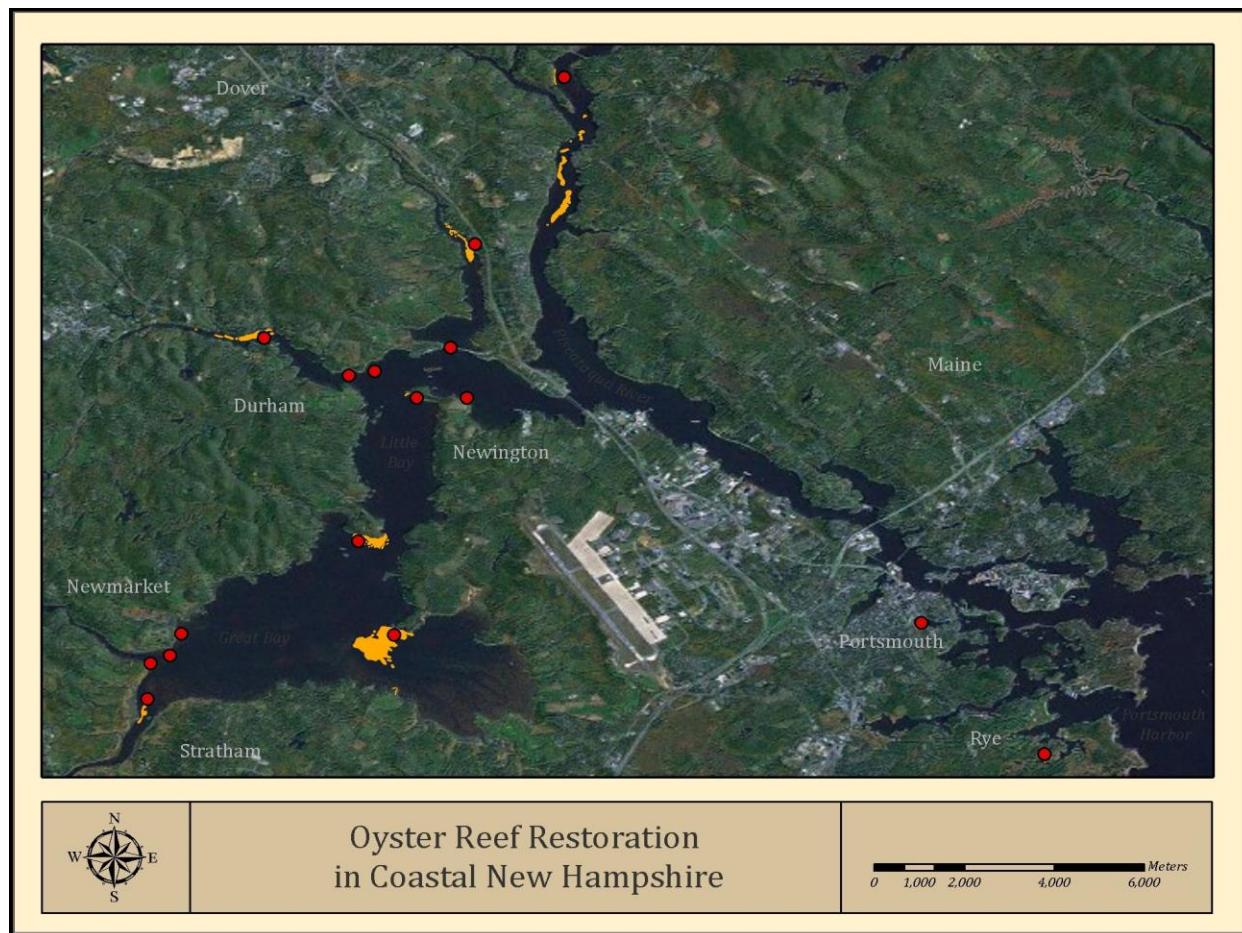
Fig. 1. General locations of major oyster restoration projects since 2000 (red circles) in relation to six major natural oyster beds (yellow polygons).

It was not possible to determine how many historical reef areas (Fig. 2) and recent major restoration areas (Fig. 1) could be mapped within time and budget constraints. Thus, a prioritized listing of the areas that were proposed for surveying was developed (Table 1).

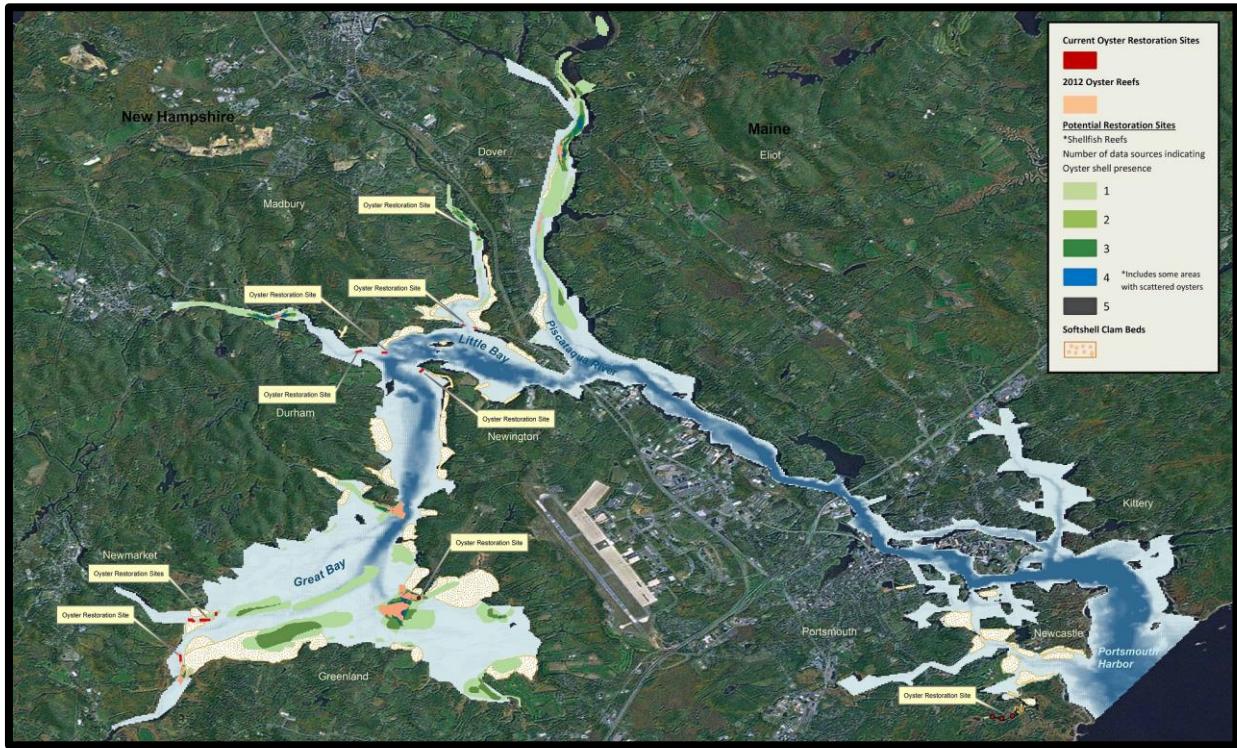
Fig. 2. Locations where live oysters (green to blue polygons) were shown on historical maps; note color coding to show the number of historical maps where each bed was shown, thus giving an estimate of accuracy), and major recent oyster restoration projects (revised from Odell et al. 2006) (also see Fig. 1).

is also a need to determine the boundaries of some of the oyster restoration projects that have been conducted since 2000. Therefore, the second objective of the present project was to map as many of the areas as practical where available information indicated live oysters historically occurred in the Great Bay Estuary, and where major recent restoration projects have been completed (Fig. 2).

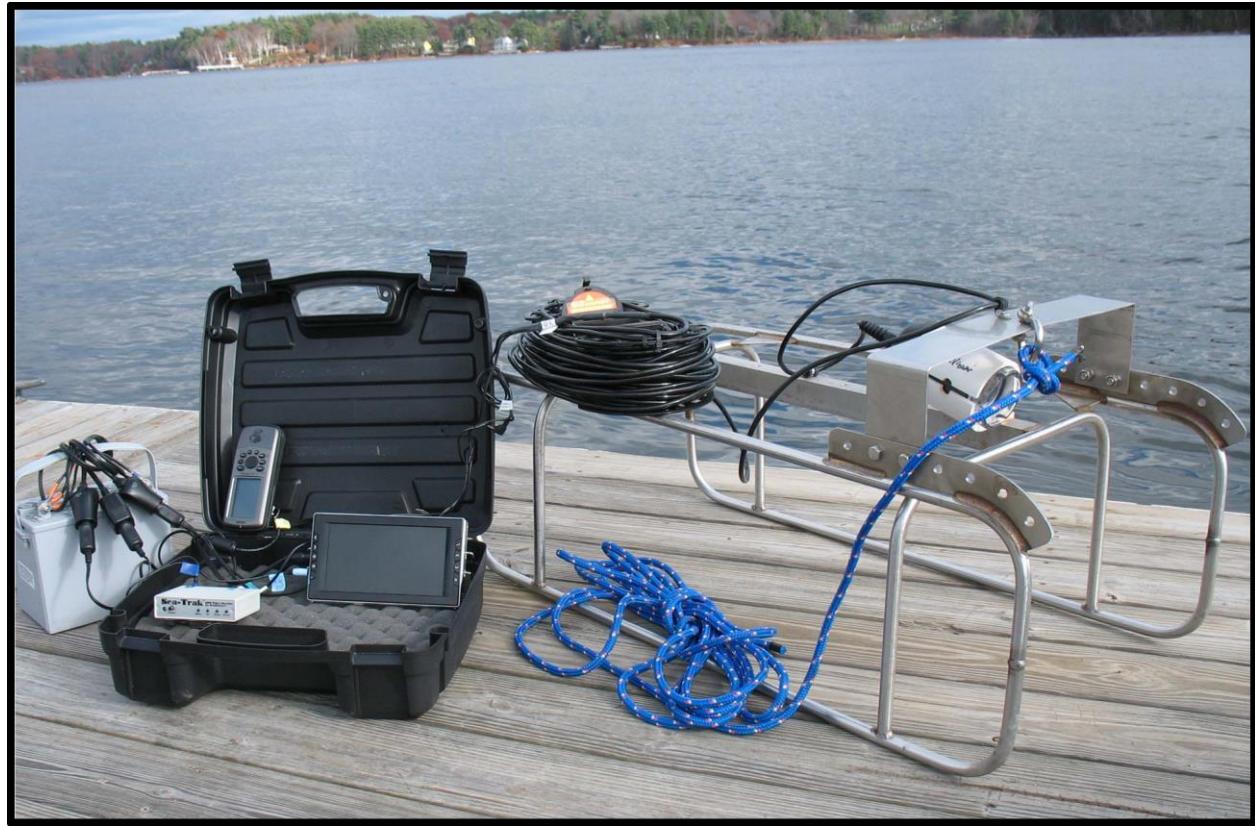
Fig. 3. Towed underwater video system showing major components (see text for details).

Towed underwater videography was used to map the six major oyster beds in the Great Bay Estuary system that are regularly sampled by NHF&G (Objective 1; see above), and historical beds and major restoration areas (Objective 2; Table 1). Methods used in previous surveys (Grizzle and Brodeur 2004; Grizzle and Ward 2009) and as described in detail in Grizzle et al. (2008) were used in the present project. Briefly, a video system consisting of a SeaViewer model 550 color camera was deployed in towed mode on a sled with imagery continuously recorded onto a digital video recorder along multiple transects across each mapping area and extending beyond the boundaries of where live oysters were observed (Fig. 3). A Garmin 76CSx GPS unit was used with WAAS mode activated and horizontal position data recorded near-continuously along each shiptrack and overlaid onto the video imagery. A minimum of five transects were traversed along the major axis of each mapping area with 5 to 20 m distance between transects. All imagery was reviewed in the laboratory and classified into one of two categories: “non-reef” (<20% shell cover, no live oysters visible) and “reef” (>20% shell cover and potentially [based on video imagery] live oysters).

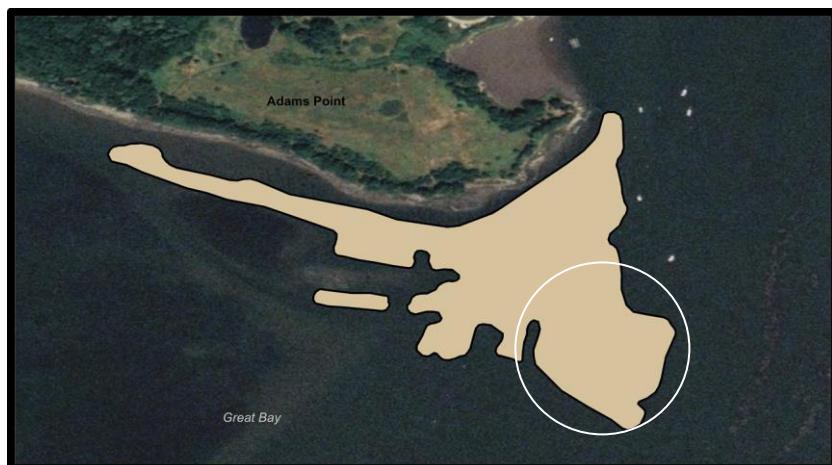
Fig. 4. Polygon for Adams Point reef based on video imagery recorded on October 8, 2012. Circle indicates bottom area probably not mapped in previous recent surveys (see Appendix A for metadata).

The Adams Point reef area appears to have increased substantially compared to the 2001 survey (Table 2). Most of the increase, however, is likely due to a new area being surveyed in 2012 southeast of the main portion of the reef (Fig. 4). Previous video surveys (e.g. Grizzle et al. 2008b) had not imaged this area due to water depth or other reasons. A portion of this “new” area had dense cover by live oysters, and had the overall appearance of a healthy reef. Based mainly on the contiguous nature of the new area with previously mapped portions of the reef, it seems likely that this area had just been overlooked in previous surveys.

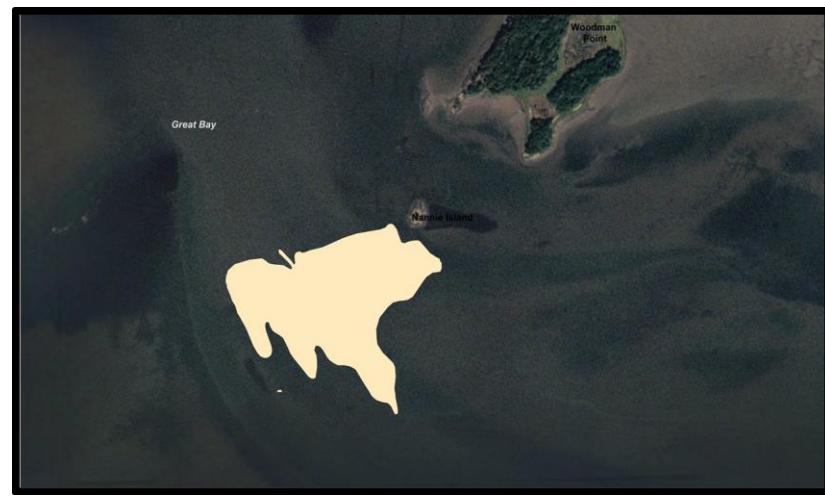
Fig. 5. Polygon for Nannie Island reef based on video imagery recorded on November 19, 2012 (see Appendix A for metadata).

The Nannie Island reef area mapped in 2012 was similar to that for 1997, but substantially less than that reported by NHF&G for 2001 (Table 2). As noted above, all previous mapping efforts differed in methods used and/or how “reef” or “shell bottom” area was defined. Thus, direct comparisons are not possible. Our previous studies on this reef using sonar methods and towed video (as in 2012) did not quantify bottom area coverage, but comparisons of the resulting polygons (see Figs. 13 and 15 in Grizzle et al. 2008b) indicate similar overall shape and size to that for 2012 (Fig. 5). Thus, although live oyster densities have varied substantially in recent years, we suggest that the total areal coverage by live oysters on the Nannie Island reef probably has not changed substantially in the recent past.

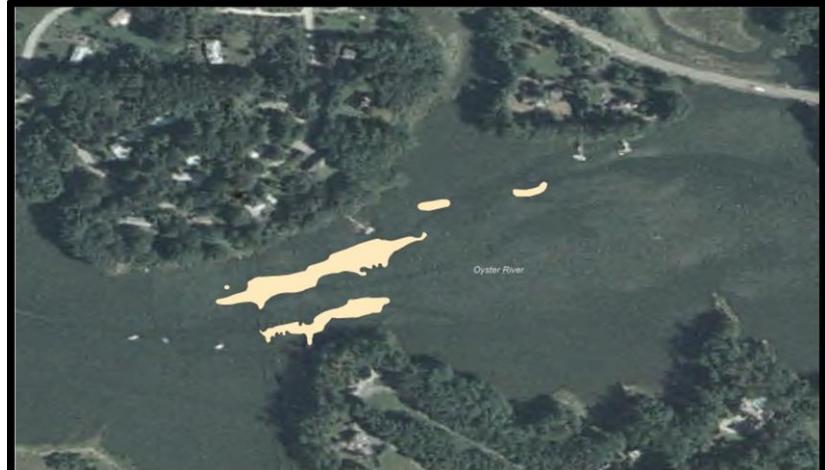
Fig. 6. Natural reef in Oyster River and two restoration areas based on video imagery recorded on November 15, 2012 (see Appendix A for metadata).

The reported Oyster River reef area coverage has only varied minimally since 1997 (Table 1). The shape of the reef, however, apparently has varied in the recent past. Previous video surveys had indicated live oyster bottom in the same overall area but no obvious “non-reef” area in the middle portion, as was found in the present survey (Fig. 6). Thus, it seems reasonable to conclude that the Oyster River reef may have decreased somewhat in size since the last survey in 2001. (See Objective 2 section below for discussion of restoration areas.)

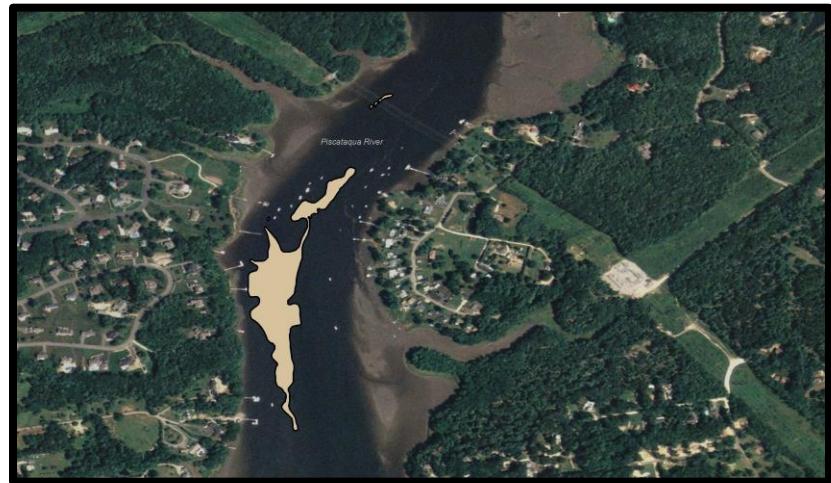
Fig. 7. Polygon for Piscataqua River reef based on video imagery recorded on November 6, 2012 (see Appendix A for metadata).

All previous surveys of the Piscataqua River reef reported much higher bottom area coverage compared to the present (2012) survey (Table 1). The general area mapped in the present survey was similar to that in previous surveys, and similar video methods were used (Grizzle and Brodeur 2004; Grizzle et al. 2008a). Also, the overall shape of the reef area was similar in 2012 in those areas where live oysters and >20% shell cover occurred (Fig. 7).

Thus, it seems reasonable to conclude that the Piscataqua River reef has decreased substantially in areal coverage since the most recent previous survey was conducted (2003).

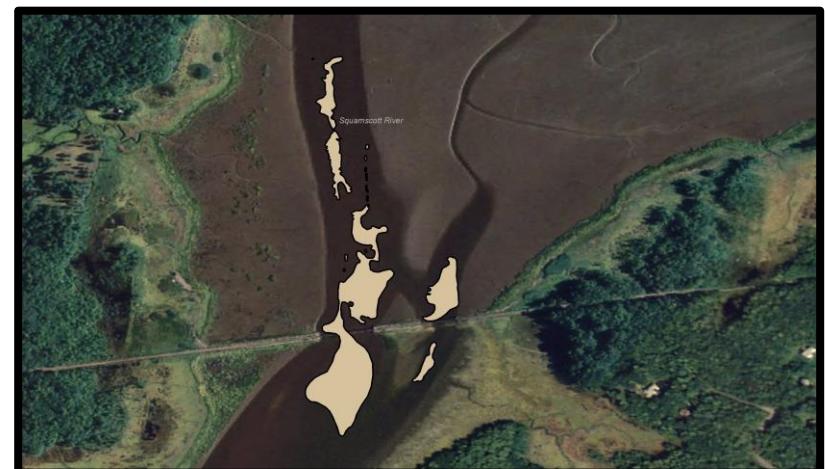
Fig. 8. Polygon for Squamscott River reef based on video imagery recorded on October 10, 2012 (see Appendix A for metadata).

The additional areas surveyed in the Squamscott River were mainly in an uncharted channel east of the main navigational channel where previous surveys had occurred (Fig. 8). When considering only those areas imaged in previous video mapping efforts, the overall shape and size of the polygons differ somewhat. For example, the area of the Squamscott reef south of the railroad trestle is larger than reported previously, but the northern area is smaller (compare Fig. 8 herein with Fig. 3 in Grizzle et al. 2008a).

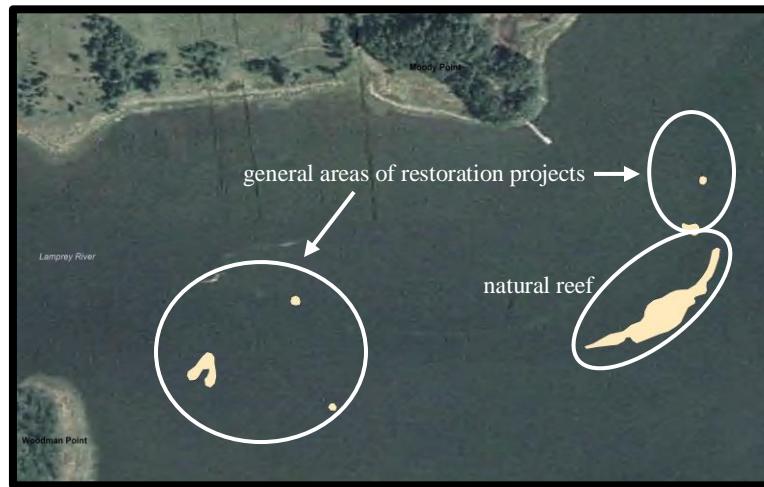
Fig. 10. Polygons for natural Lamprey River reef and two restoration areas based on video imagery recorded on June 19, 2013 (see Appendix B for metadata).

The Lamprey River survey area included a “new” natural reef that was thought to no longer exist, and two separate restoration areas (Fig. 10). Qualitative sampling on the natural reef indicated a substantial amount of vertical structure as well as some large (>100 mm shell height) individuals and multiple year classes on some clusters. The reef surface was also very hard and appeared to be quite thick, indicating many years of shell accretion. This is likely the historical reef known to have been in existence for decades. The restoration areas shown in Figure 10 were constructed in 2011 by deposition of a base layer of dead mollusc (mostly surf clams) followed by scattered live oyster spat-on-shell produced by remote setting. Most of the “reef” areas shown represent some combination of surf clam shell and live oysters from the spat-on-shell put out as part of the restoration process and naturally recruited oysters.

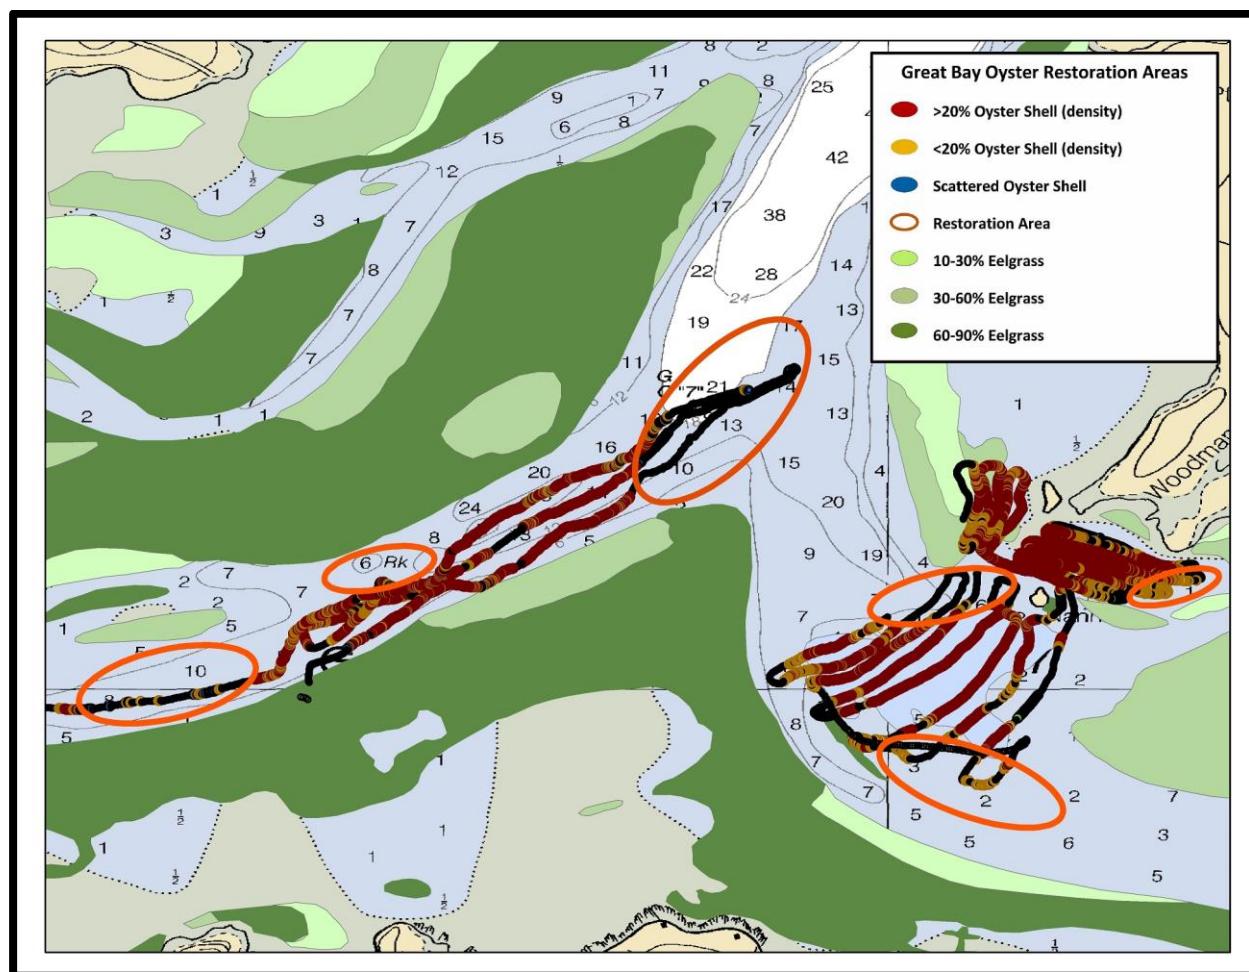
Fig. 11. Composite map showing potential oyster restoration areas (orange polygons) in Great Bay based on 2012 classified video shiptracks and recent (201x) mapping of eelgrass on bathymetric chart base map (water depth in feet).

The natural oyster reef shown on some historical maps (Fig. 2; also see Odell et al. 2006) in the channel area of middle and western Great Bay was found to be extensive, with “reef” (>20% shell and live oysters visible) area covering 35.2 acres (Fig. 11; Appendix B). The general area also included a substantial amount of sparse shell bottom, mostly consisting of dead oyster shell. The extent of live oyster reef in this area was surprising. Moreover, the extent of sparse shell bottom extending away from the main reef at both ends (east and west) likely indicated the historical spatial extent of this reef. This spatial arrangement of features—a central area of dense live oysters with adjacent areas of sparse mostly dead shell—suggests excellent conditions for future oyster restoration projects. Additionally, the same general situation exists in the nearby Nannie Island/Woodman Point reef area. Therefore, a map showing these conditions as well as the most recent available (from 2012) map of eelgrass was produced to illustrate the extent of potential oyster restoration sites for central Great Bay (Fig. 11). Although more detailed mapping of each of the six potential oyster restoration areas would be needed to adequately design each project, we estimate that >100 acres of bottom area likely represents excellent oyster restoration opportunities.

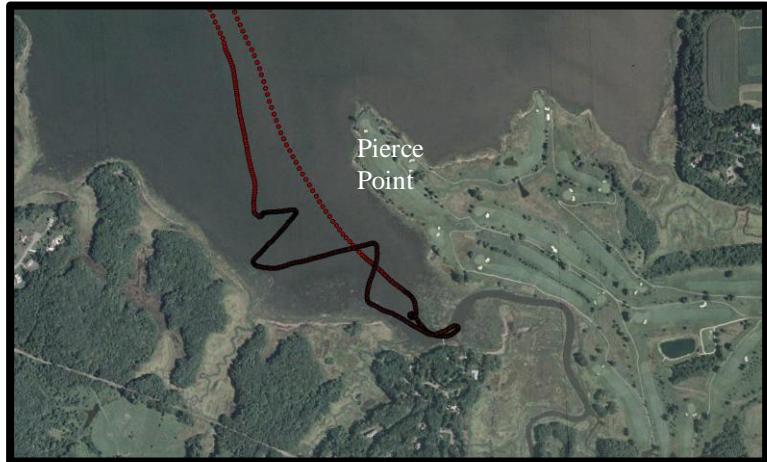
Fig. 12. Shiptracks recorded on June 19, 2013 showing area in southeastern Great Bay where oyster reef occurred historically.

The general area of a historical natural oyster bed in southeastern Great Bay at the mouth of the Winnicut River (see Fig. 2 above) was surveyed by navigating a zig-zag pattern out of the River and probing the bottom with a PVC pipe to determine bottom type (Fig. 12). The entire area consisted of muddy substrate, very soft in many places. Shell material was only encountered in a few areas near mid-channel just south of Pierce Point, and included shell material beneath several centimeters of bottom sediment. No “hard bottom” was encountered.

This overall combination of conditions suggests that the reef may have been buried during a storm or other event involving substantial sediment transport. We have observed a similar situation in the Bellamy River at an oyster restoration site. Thus, we conclude that most likely this reef no longer exists.

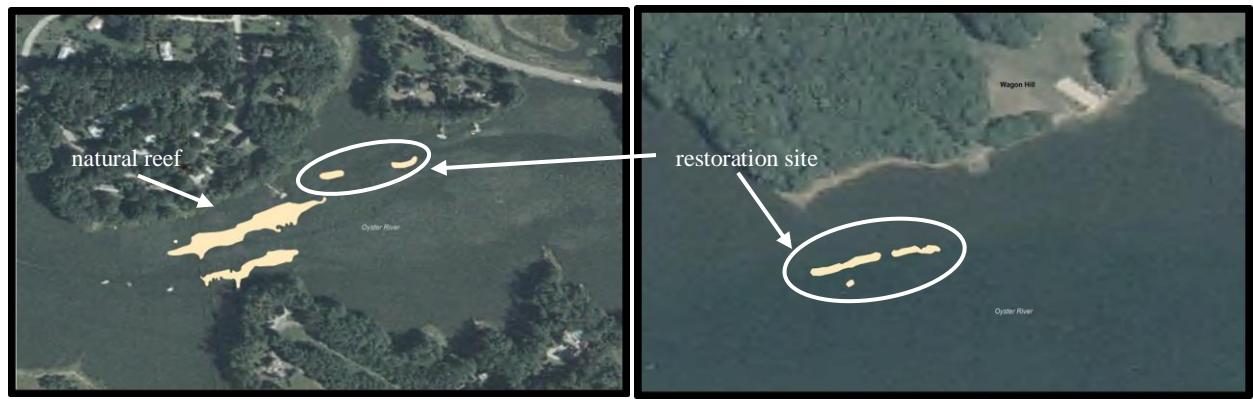
Fig. 13. Polygons showing extent of “shell bottom” at two oyster restoration sites in the Oyster River based on video imagery recorded on June 19, 2013 (See Appendix B for metadata).

In addition to the natural reef in the Oyster River, two oyster restoration sites were mapped in 2013. The first area was adjacent to the natural reef, and the second was near the mouth of the Oyster River (Fig. 13; also see Fig. 6 above). Both were constructed by deposition of a base layer of dead

mollusc (mostly surf clams) followed by scattered oyster spat-on-shell produced by remote setting. The video imagery indicated some combination of surf clam shell and live oysters in both areas. The video imagery confirmed the presence of abundant mollusc shell base material as well as live oysters in both areas. The base shell in most areas had a thin coating of silt, and some appears to have been substantially buried. Macroalgae had colonized the shell in many areas, and crabs and other invertebrates were visible in the imagery. These areas are scheduled for quantitative sampling and additional characterization by video and other methods in 2013.

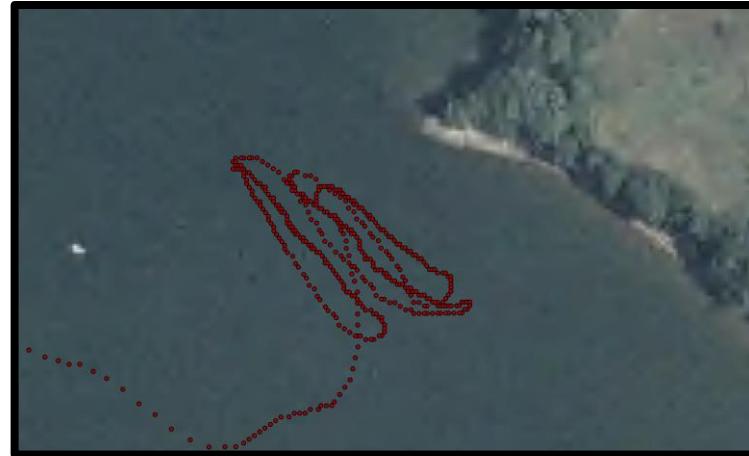
Fig. 14. Polygon for oyster restoration site in Little Bay at Fox Point based on video imagery recorded on June 19, 2013 (see Appendix B for metadata).

The final restoration site mapped in 2013 was at Little Bay/Fox Point, which was constructed in 2010 (Fig. 14). This area was chosen for restoration because most of the site was on natural rocky bottom, and adjacent to a natural oyster reef that had not been previously mapped or sampled. Unfortunately, the video imagery recorded in 2013 was of poor quality in most areas. The entire area covered by the shiptracks shown in Figure 14 was rocky bottom with substantial macroalgal patches, and live oysters were observed in many areas. This area is scheduled for more video imaging and quantitative sampling in 2013.

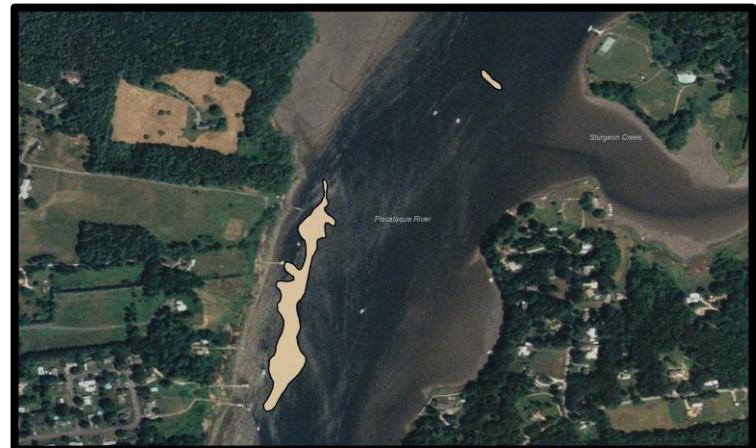
Fig. 15. Polygon for natural Piscataqua (South) River reef based on video imagery recorded on November 6, 2012 (see Appendix B for metadata).

In addition to the target survey areas listed in Table 1, a “new” natural reef was discovered in 2012 while using towed video to survey a potential restoration site in the Piscataqua River. This reef is south of the known Piscataqua River reef regularly sampled by NHF&G, but it is within the overall area of the upper Piscataqua River that historically had natural beds (Fig. 2). This “new” reef covered a bottom area of 3.9 acres, and represents a significant addition to the known natural oyster beds in New Hampshire (Fig. 15). A 1.5-acre area adjacent to and east of the natural bed is scheduled for construction/restoration in summer 2013. The restoration area will represent an addition onto the natural reef, likely in an area that historically was live oyster reef. The restoration area is scheduled for quantitative sampling and video mapping in 2013 and 2014.

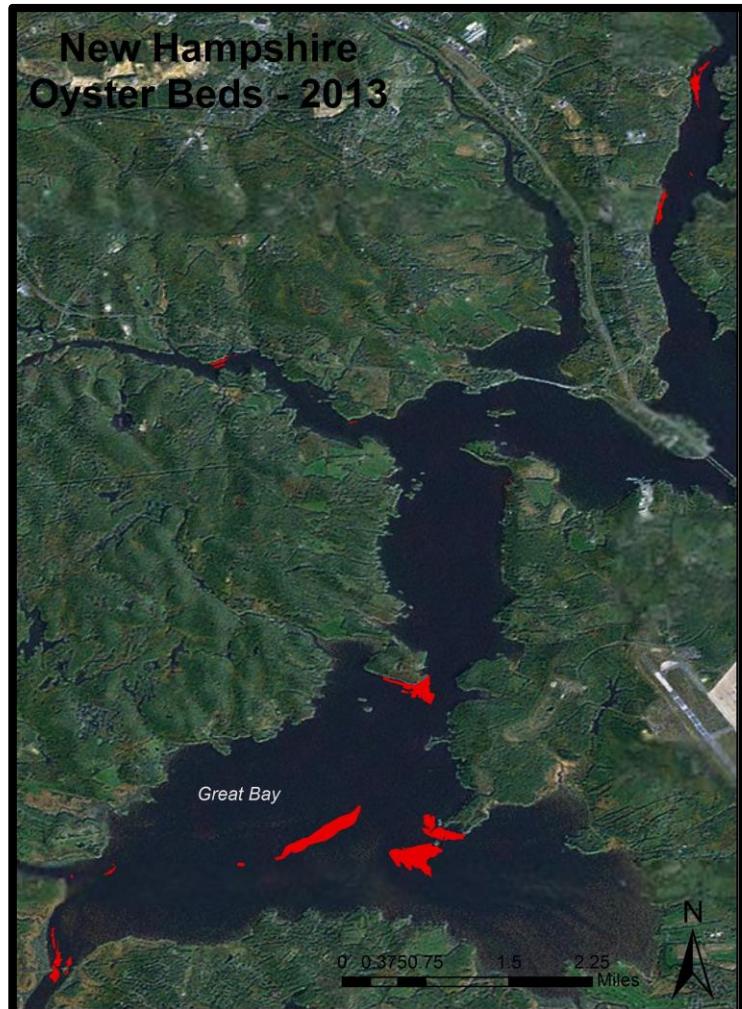
Fig. 16. Natural and restored oyster reefs mapped in the present project (red polygons).

The present study substantially expands the total bottom area coverage and overall distribution of known “oyster bottom” in New Hampshire. Figure 16 is an overview map showing both natural and restored oyster beds—defined as >20% shell cover and some live oysters observed in the video imagery—mapped in the present study. In sum, these areas total 120 acres. The major additions compared to previous surveys were two “new” beds, one in mid-Great Bay (35.2 ac) and one at the mouth of the Lamprey River (0.9 ac), that were known to occur historically but had not been surveyed in recent decades.

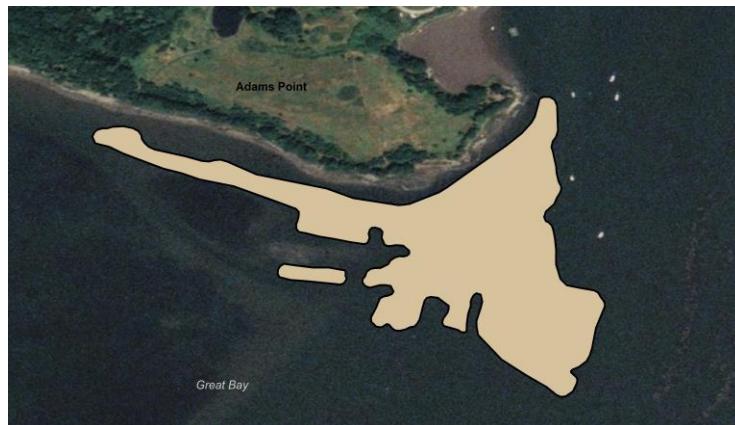
At each site surveyed, a SeaViewer model 550 color video camera was deployed in towed mode on a sled with video imagery continuously recorded onto a digital video recorder. Garmin 76CSx and 541s GPS units were used with WAAS mode activated, with horizontal position data (advertised positional accuracy: 3 m) recorded near-continuously along each shiptrack. The imagery was viewed in real-time to locate areas with significant amounts of oyster shell and live oysters. When oysters were encountered, the extent of the oyster bottom in that area was delineated by navigating multiple parallel transects. All imagery was later reviewed in the laboratory and classified into the category of: "high density" oysters (>20% cover by shell and some live oysters visible). This provided near-continuous classification of the seafloor along each shiptrack. The Adams Point Oyster Bed polygon is 15.9 acres.

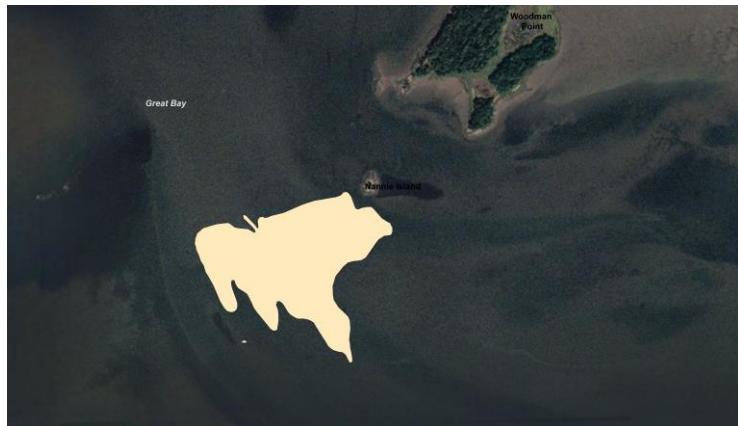
At each site surveyed, a SeaViewer model 550 color video camera was deployed in towed mode on a sled with video imagery continuously recorded onto a digital video recorder. Garmin 76CSx and 541s GPS units were used with WAAS mode activated, with horizontal position data (advertised positional accuracy: 3 m) recorded near-continuously along each shiptrack. The imagery was viewed in real-time to locate areas with significant amounts of oyster shell and live oysters. When oysters were encountered, the extent of the oyster bottom in that area was delineated by navigating multiple parallel transects. All imagery was later reviewed in the laboratory and classified into the category of: "high density" oysters (>20% cover by shell and some live oysters visible). This provided near-continuous classification of the seafloor along each shiptrack. The Nannie Island Oyster Bed polygon is 32.4 acres.

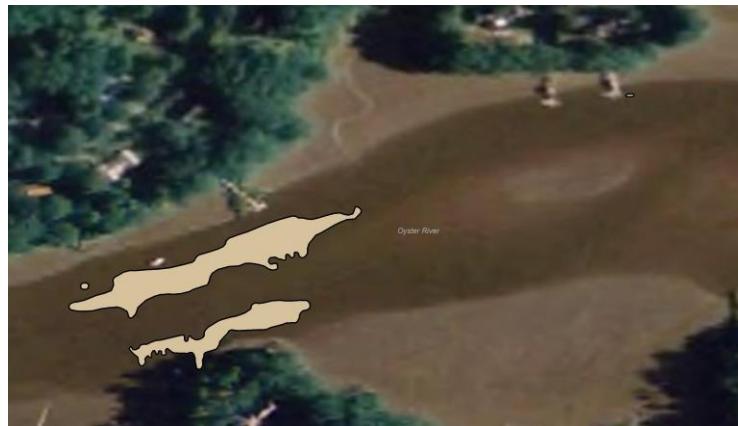
At each site surveyed, a SeaViewer model 550 color video camera was deployed in towed mode on a sled with video imagery continuously recorded onto a digital video recorder. Garmin 76CSx and 541s GPS units were used with WAAS mode activated, with horizontal position data (advertised positional accuracy: 3 m) recorded near-continuously along each shiptrack. The imagery was viewed in real-time to locate areas with significant amounts of oyster shell and live oysters. When oysters were encountered, the extent of the oyster bottom in that area was delineated by navigating multiple parallel transects. All imagery was later reviewed in the laboratory and classified into the category of: "high density" oysters (>20% cover by shell and some live oysters visible). This provided near-continuous classification of the seafloor along each shiptrack. The Oyster River Oyster Bed polygon is approximately 1.4 acres.

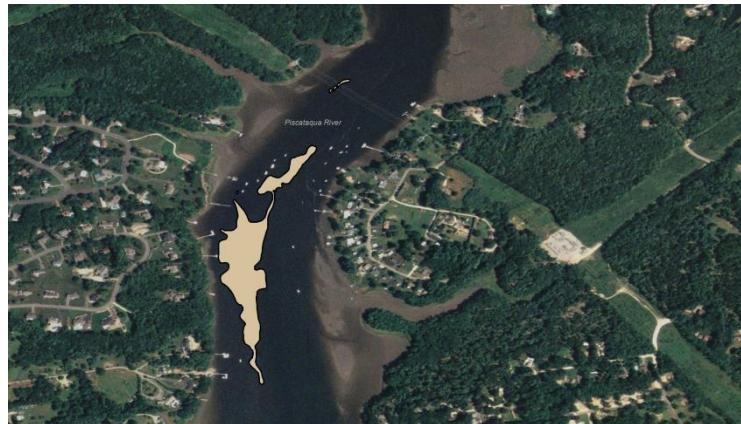
At each site surveyed, a SeaViewer model 550 color video camera was deployed in towed mode on a sled with video imagery continuously recorded onto a digital video recorder. Garmin 76CSx and 541s GPS units were used with WAAS mode activated, with horizontal position data (advertised positional accuracy: 3 m) recorded near-continuously along each shiptrack. The imagery was viewed in real-time to locate areas with significant amounts of oyster shell and live oysters. When oysters were encountered, the extent of the oyster bottom in that area was delineated by navigating multiple parallel transects. All imagery was later reviewed in the laboratory and classified into the category of: "high density" oysters (>20% cover by shell and some live oysters visible). This provided near-continuous classification of the seafloor along each shiptrack. The Piscataqua River Oyster Bed polygon is 7.7 acres.

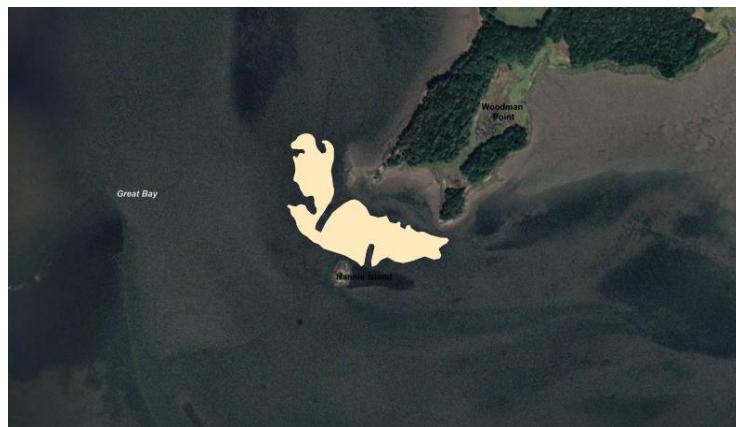
At each site surveyed, a SeaViewer model 550 color video camera was deployed in towed mode on a sled with video imagery continuously recorded onto a digital video recorder. Garmin 76CSx and 541s GPS units were used with WAAS mode activated, with horizontal position data (advertised positional accuracy: 3 m) recorded near-continuously along each shiptrack. The imagery was viewed in real-time to locate areas with significant amounts of oyster shell and live oysters. When oysters were encountered, the extent of the oyster bottom in that area was delineated by navigating multiple parallel transects. All imagery was later reviewed in the laboratory and classified into the category of: "high density" oysters (>20% cover by shell and some live oysters visible). This provided near-continuous classification of the seafloor along each shiptrack. The Woodman Point Oyster Bed polygon is 15.4 acres.
